Inspection Report
Minerals Regulatory Program
Date: August 21, 2008

Mine Name: RLR Site #4	Permit Number: S0470095
Operator Name: Red Leaf Resources, inc.	Inspection Date: 08/19/2008
Inspector(s): Brett Gregory (for Leslie Heppler)	Time: 1:00 pm
Other Participants: None	Mine Status: Active

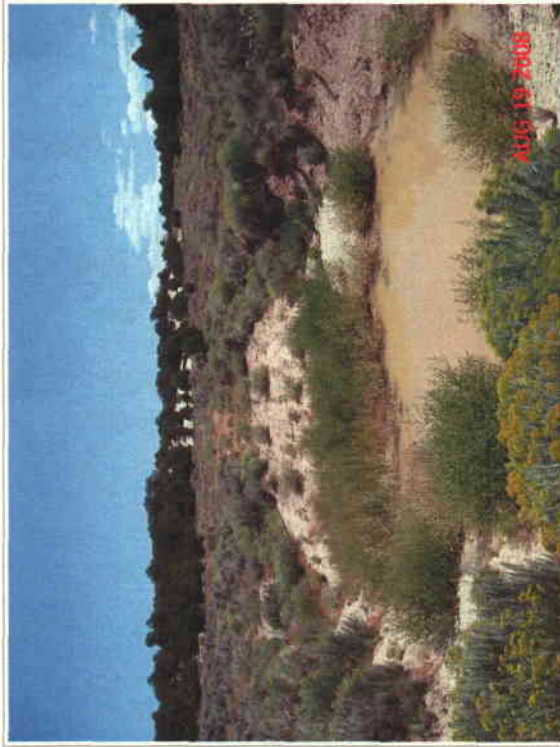
3. Ponding water shown in the pictures is pre-existing. The drainage is already eroded quite a bit

Ponding water.

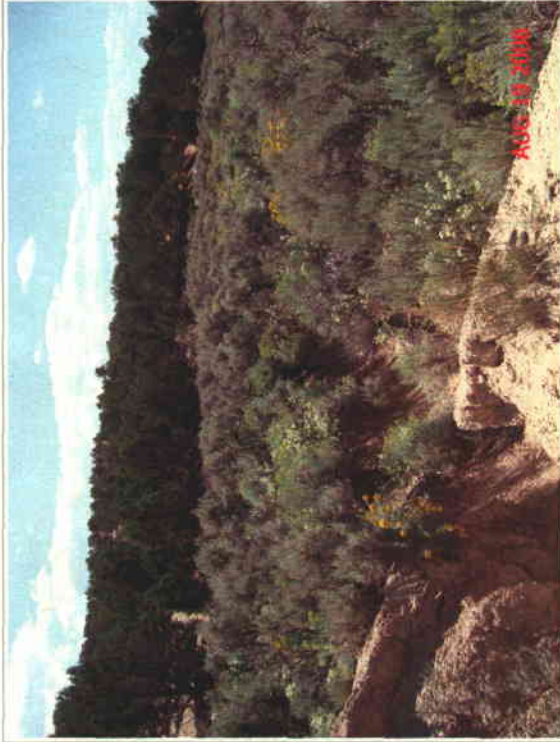
Existing erosion.

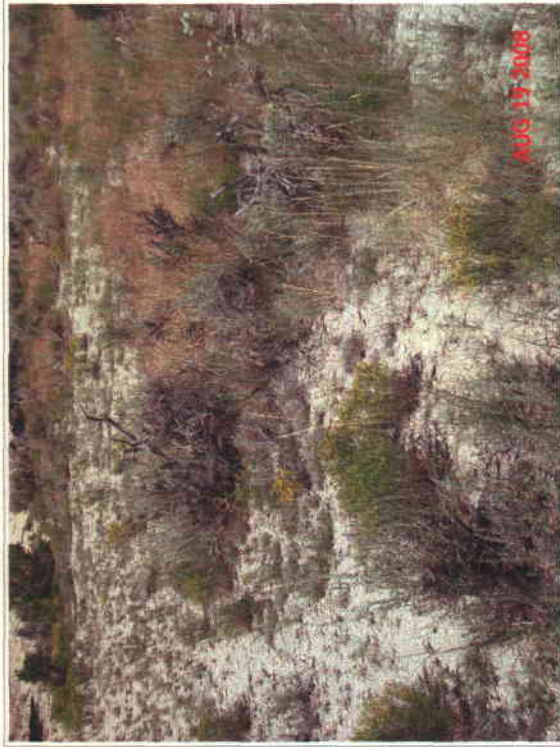
Plant vegetation.

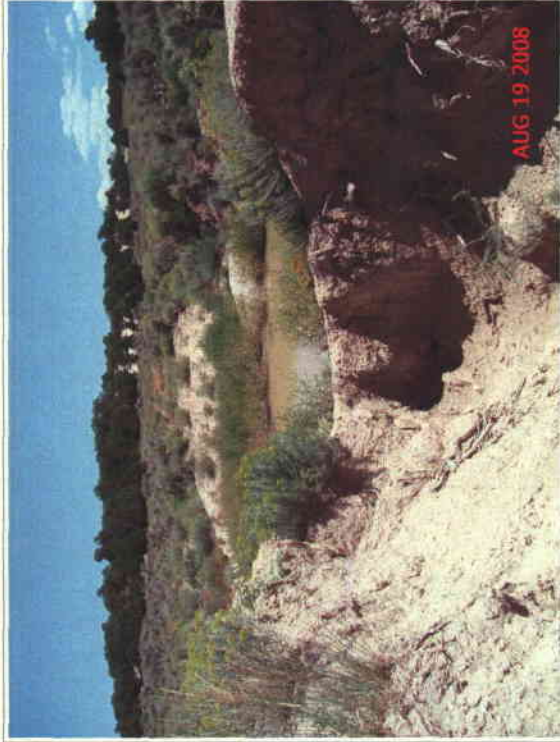
Lower view of what has already eroded.
